Current Groundwater Quality Conditions at the historic Rum Jungle mine site, Northern Territory (Australia)

Paul Ferguson & Christoph Wels

Robertson GeoConsultants Inc.

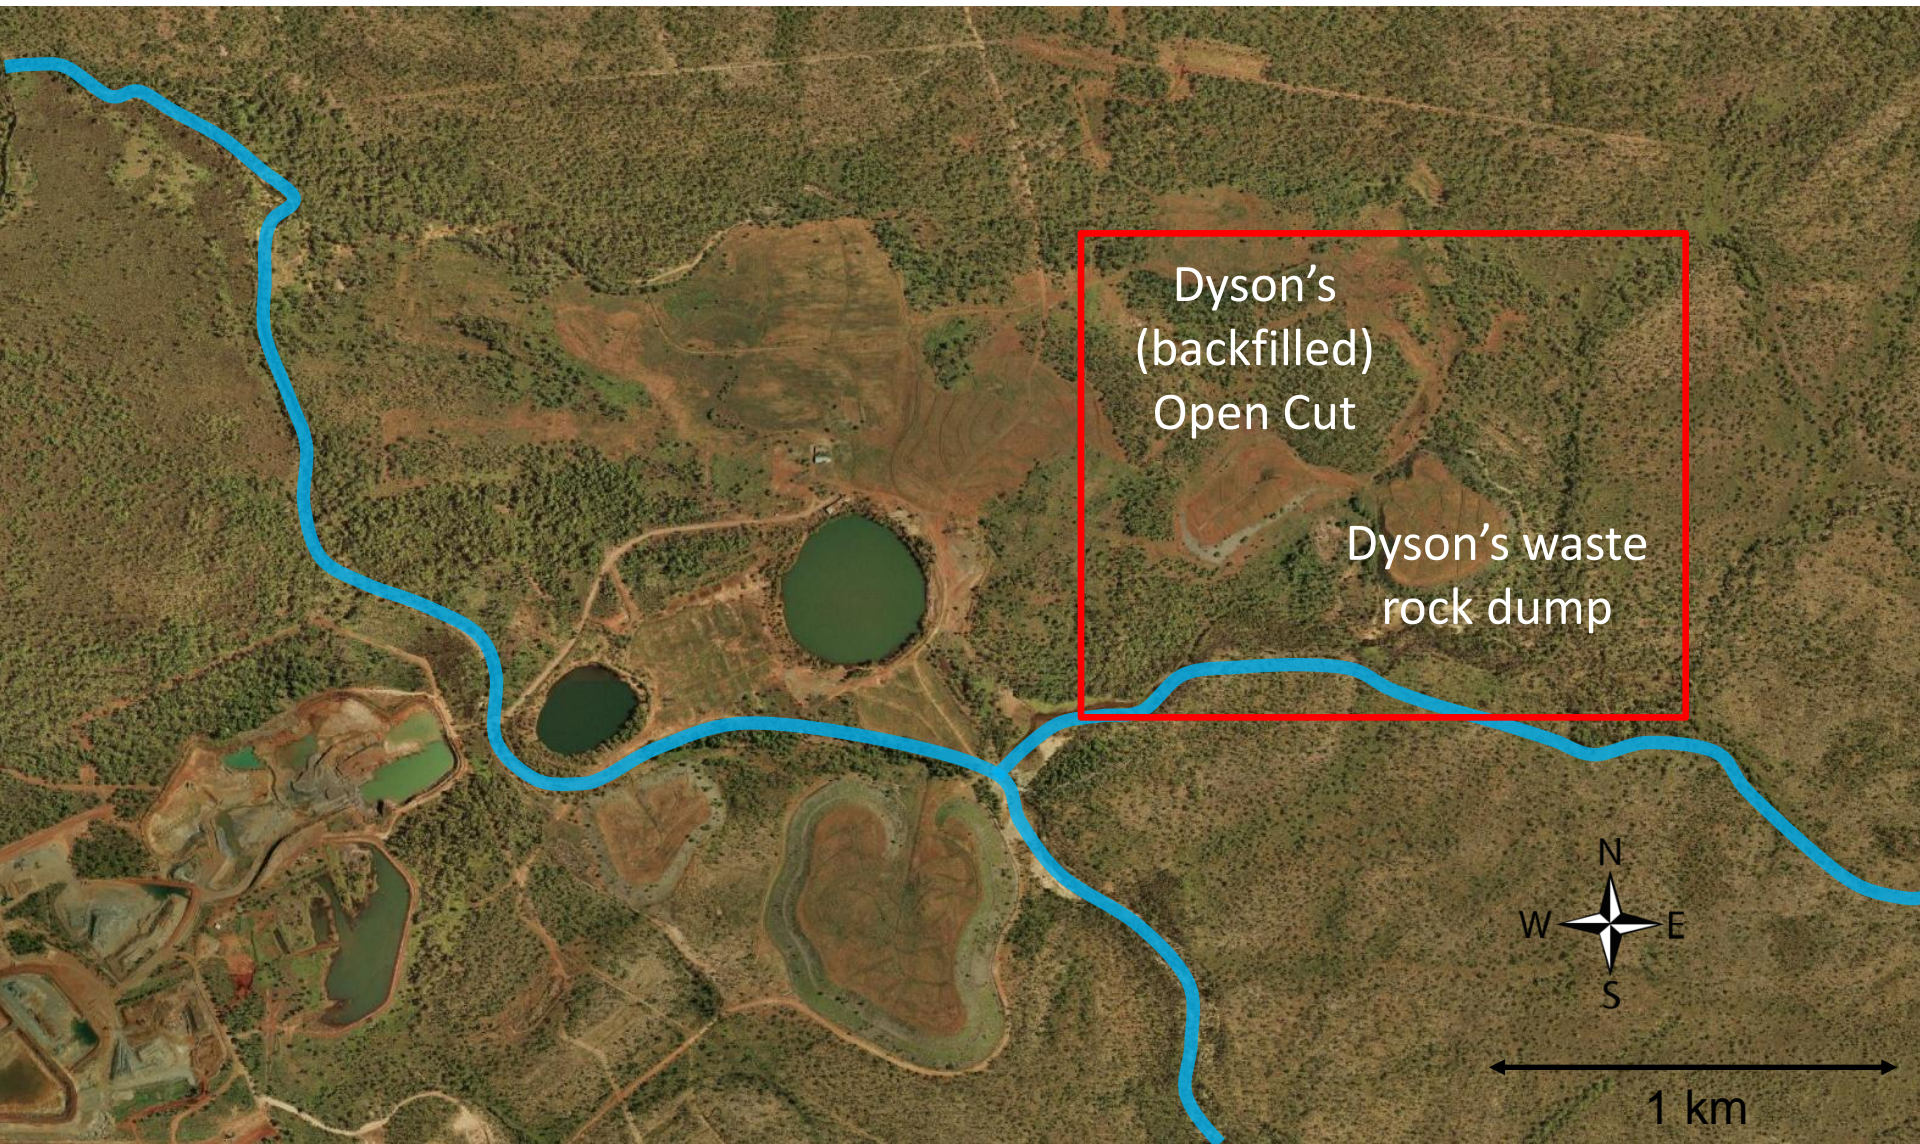
Central mine area

White's Open Cut & waste rock pile

Intermediate Open Cut & waste rock pile

Brown's Oxide pit (proposed)

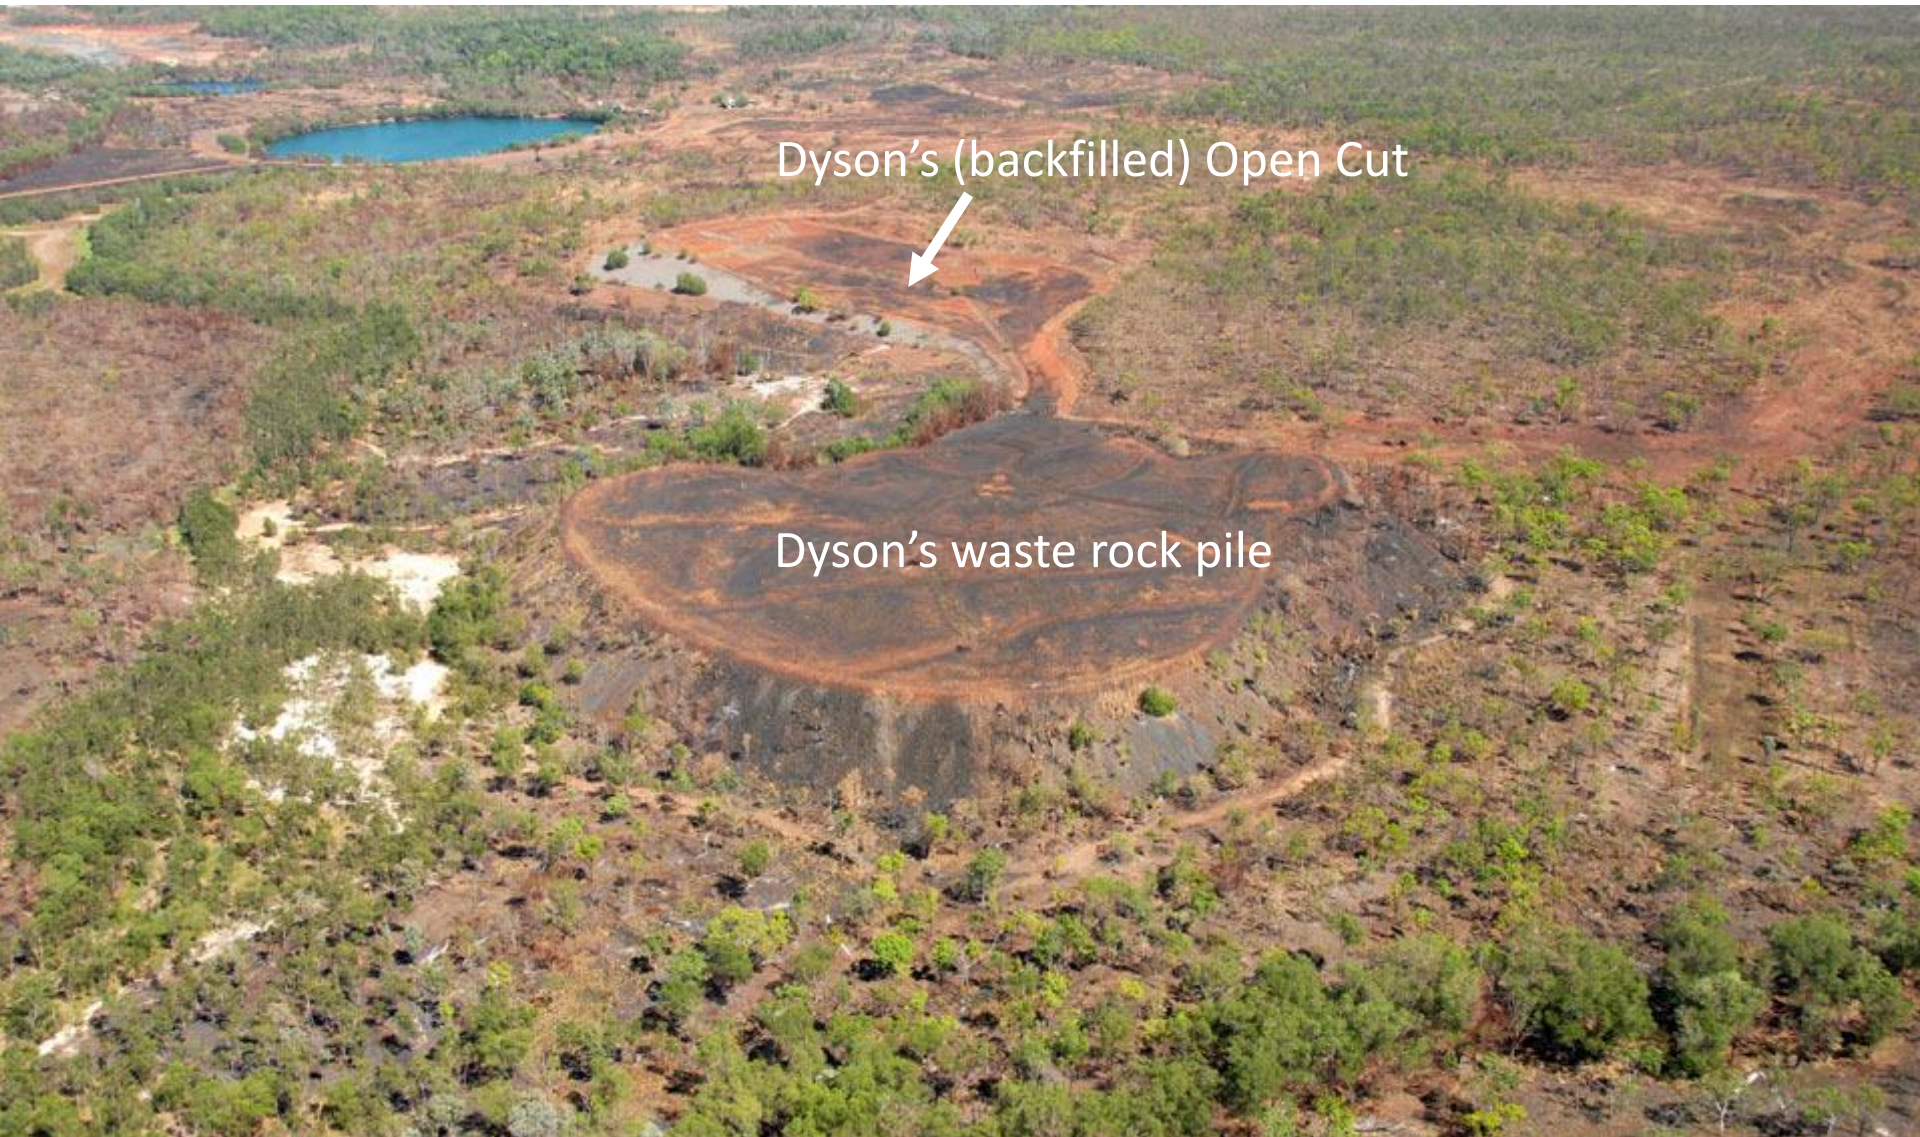
Dyson's Area

Dyson's (backfilled) Open Cut

Dyson's waste rock pile

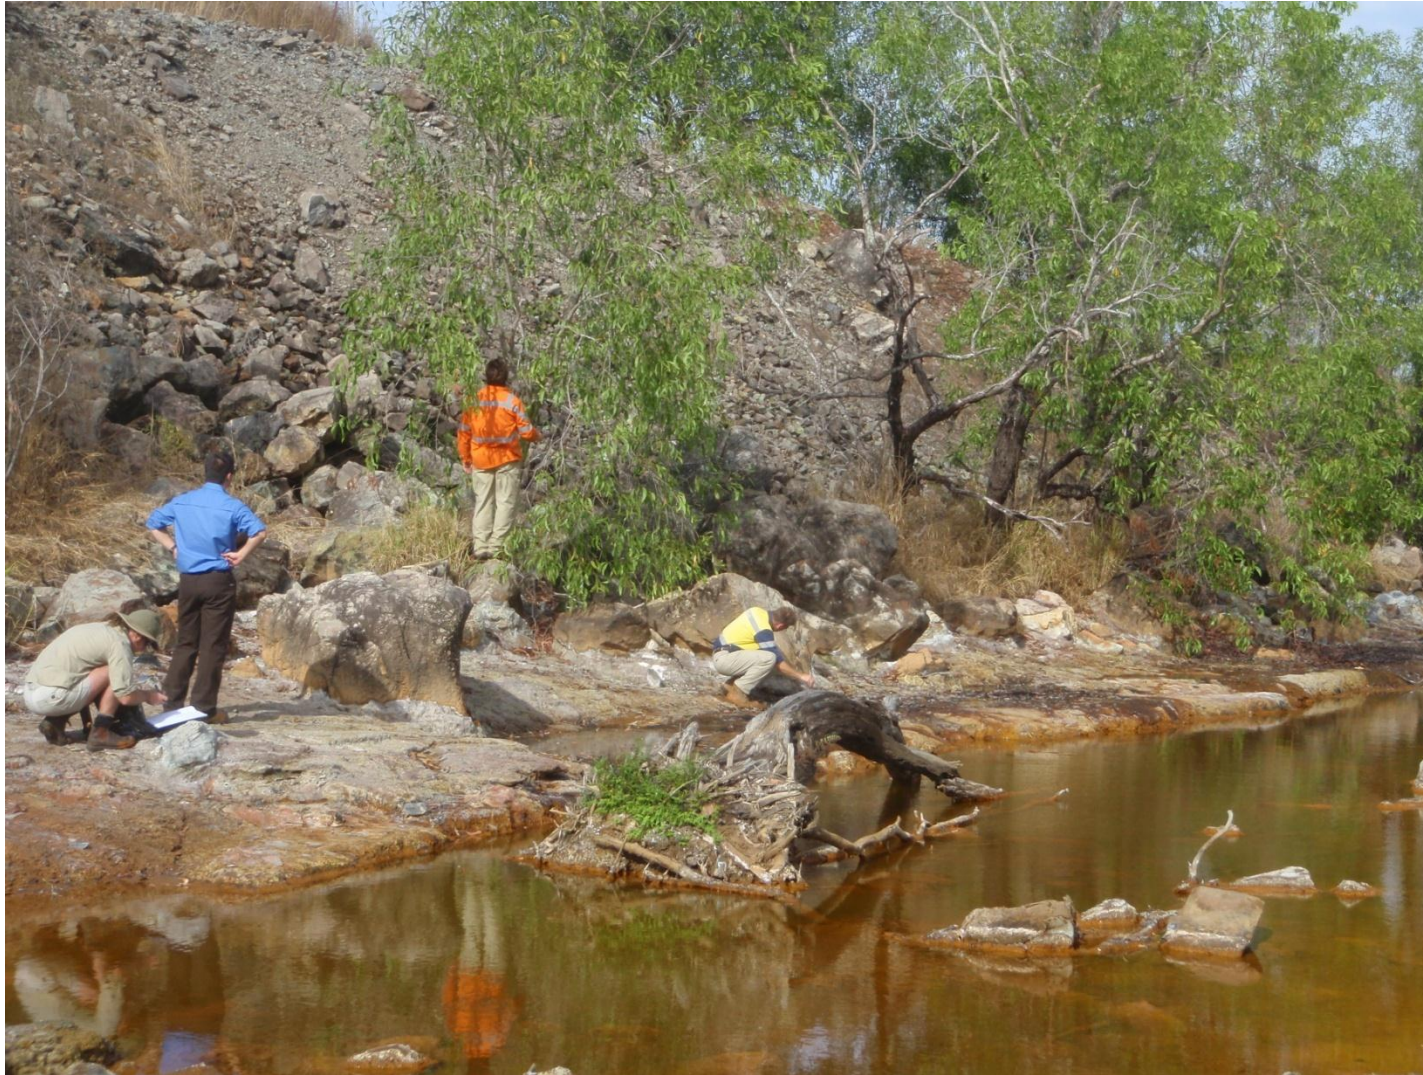
Seepage loads to surface water

Annual loads
(t/yr)

2,500 SO₄

11 Cu

56 Fe

8 Zn

+ 20 to 25%
from Dyson's
& Open Cuts

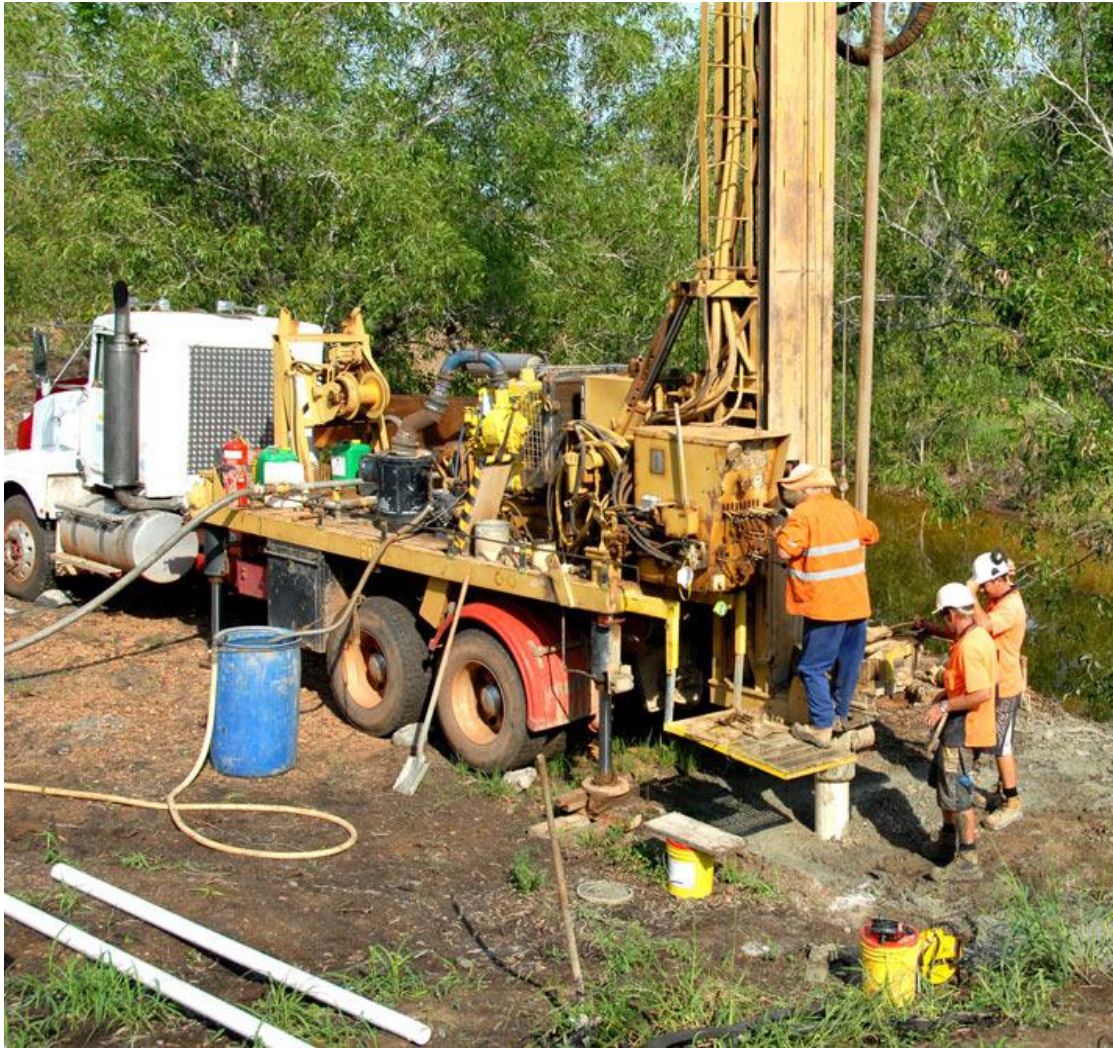
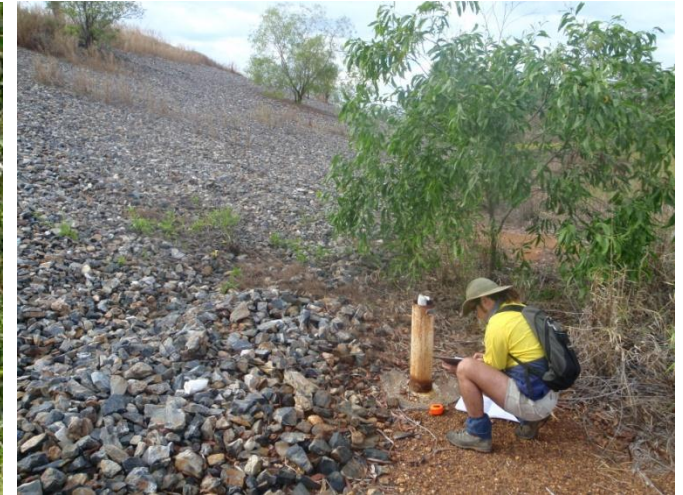
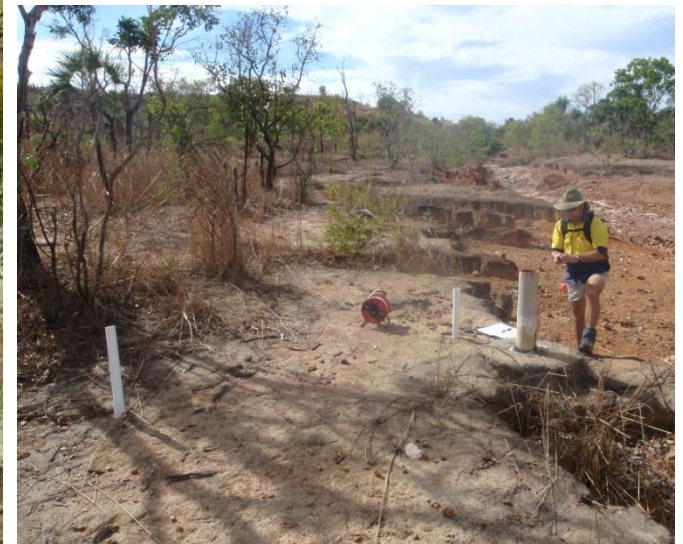
Groundwater quality conditions poorly-characterized

103 historic monitoring wells & 27 new wells installed in 2010

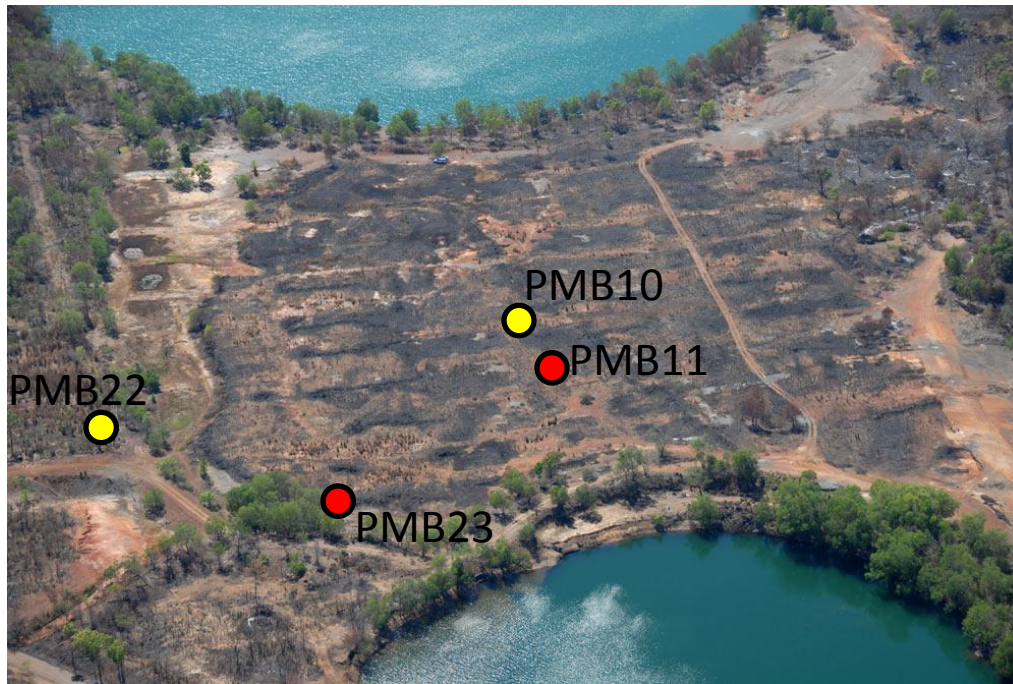
Groundwater beneath the former heap leach area

- Relatively unimpacted by ARD
- Highly-acidic, metals-laden water (residual seepage from heap leach)

Samples from December 2010

Well	pH	SO ₄ , mg/L	Al, mg/L	Cu, mg/L	Co, mg/L	Ni, mg/L	Zn, mg/L
PMB11	5.0	5,600	1	137	76	51	9
PMB23	3.5	5,340	38	506	74	56	11
